Manhole Inspection Summary

Manhole # S33AA1035MH

Location Address: **JOHN HOPKINS COLLEGE**

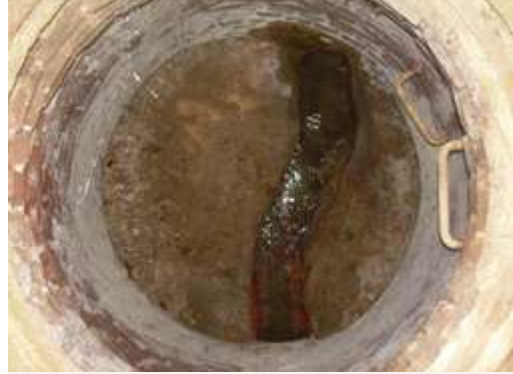
Top View

☒ **Evidence Of Surcharge** Depth: **1.5** (ft.) ☐ Active Surcharge Present

Evidence of surcharge- Bench debris.

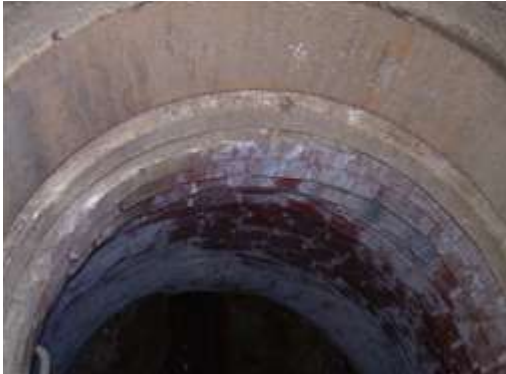
Defect

Condition: ☐ Sound ☐ Cracked ☒ **Leaks**

Infiltration: ☐ None ☒ **Joint** ☐ Cracks ☐ Mortar ☐ Roots ☒ **Wall**

Condition: ☐ Sound ☐ Cracked ☐ Root Intrusion ☐ Loose Brick ☒ **Deteriorated**

Infiltration: ☐ None ☐ Joint ☐ Cracks ☒ **Mortar** ☐ Roots ☒ **Wall**

Infiltration: ☐ None ☐ Joint ☐ Cracks ☐ Mortar ☐ Roots ☒ **Wall**

Frame leaks. Adjustment infiltration. Corbel deterioration and infiltration. Barrel infiltration -other side.

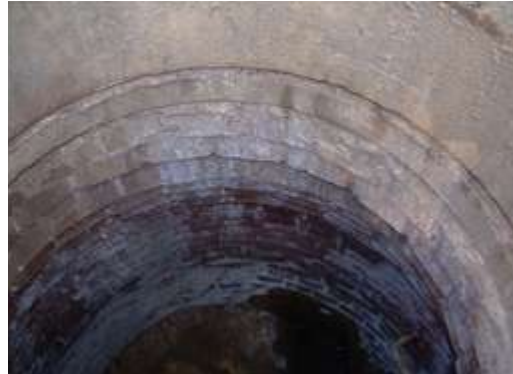
Defect

Frame leaks. Adjustment infiltration. Corbel deterioration and infiltration. Barrel infiltration.

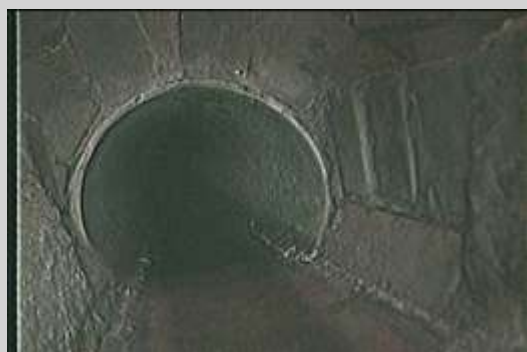
Pipe In @ 6 O'Clock

Condition: ☐ Sound ☐ Cracked ☐ Root Intrusion ☒ **Deteriorated** ☐ Leaks ☐ Debris

Channel deterioration.

Pipe Seal Cond: **Cracked**
